So Cal Surveys, LLC

Survey Report

Formosa 51

Eagle

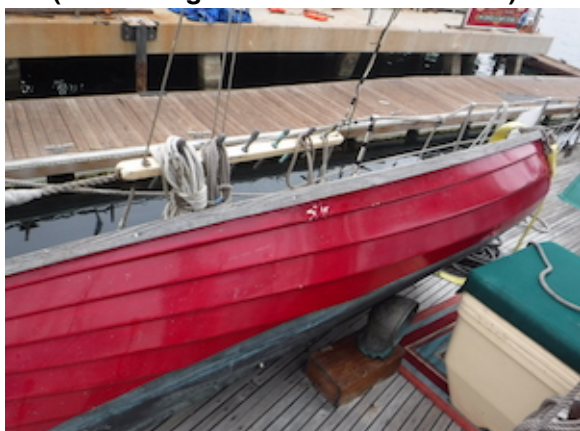
The fiberglass dinghy appears in good condition. There is some fiberglass damage to the dinghy.

C.3 (see findings and recommendations)

FINDINGS	RECOMMENDATIONS
C.1 There is some damage to the bulkhead at the exhaust muffler.	Repair or patch the holes in the bulkhead.
C.2 The teak decking is worn with some exposed screw head. Some the deck sealing is missing.	Repair and reseal the teak decks.
C.3 There is some fiberglass damage to the dinghy.	Repair the dinghy as necessary.
C.4 The Icom IC-M710 transceiver is not operational.	Make the transceiver operational if necessary.
C.5 The Raymarine C80 radar powers up but shows No Data Source.	Make the radar operational if necessary.
C.6 The Raymarine C80 GPS chartplotter powers on but does not find the ships location.	Make the chartplotter operational if necessary.
C.7 The speed paddle wheel is missing.	Replace the missing paddle wheel if necessary.
C.8 The oil gage lens is missing.	Repair or replace the oil gage.
C.9 The engine temperature gage appears to be not accurate.	Test and calibrate the engine gages as necessary.

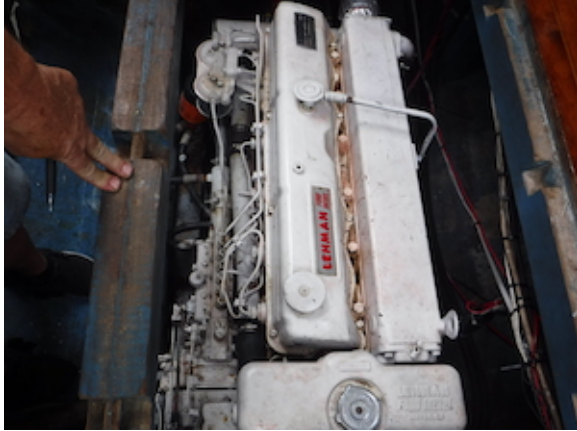
The engine is in good operational condition with signs of regular maintenance. The engine compartment is clean and orderly. There is oil in the bilge.

B.3 (see findings and recommendations)

FINDINGS	RECOMMENDATIONS
B.1 The blower is not operational.	Make the bilge blower operational.
B.2 Some of the stanchions are not secure.	Secure the stanchions.
B.3 There is oil in the bilge.	Keep bilge pads under the engine.

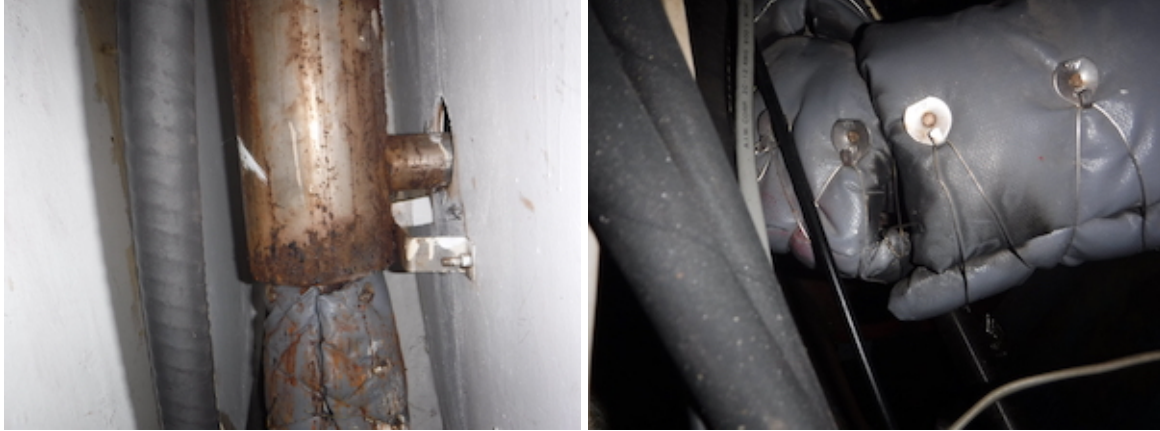
The exhaust system is wet with a long section of dry exhaust. The exhaust muffler is corroded with evidence of leaks. The exhaust muffler is located in the closet of the aft cabin. There is evidence of exhaust leaks at the exhaust pipe. There are hoses and wires in contact with the exhaust heat shield on the dry section of the exhaust pipe.

B.6, B.7, B.8, B.9 (see findings and recommendations)

B.4 The engine stalled during the sea trial due to fuel starvation. The engine was not operated at full throttle.	Confirm that the engine fuel system is operating correctly and retest the engine at full throttle for a short amount of time.
B.5 There is evidence of an oil leak at the aft end of the engine.	Clean and monitor the engine for leaks.
B.6 The exhaust muffler is corroded with evidence of leaks.	Repair or replace the muffler.
B.7 The exhaust muffler in is located in the closet of the aft cabin.	Isolate the muffler and exhaust components form the living areas.
B.8 There is evidence of exhaust leaks at the exhaust pipe.	Inspect and repair the exhaust pipe.
B.9 There are hoses and wires in contact with the exhaust heat shield on the dry section of the exhaust pipe.	Keep all wire and hoses well away from the exhaust pipe.
B.10 The shaft seal is single clamped.	Double clamp the shaft seal hose.

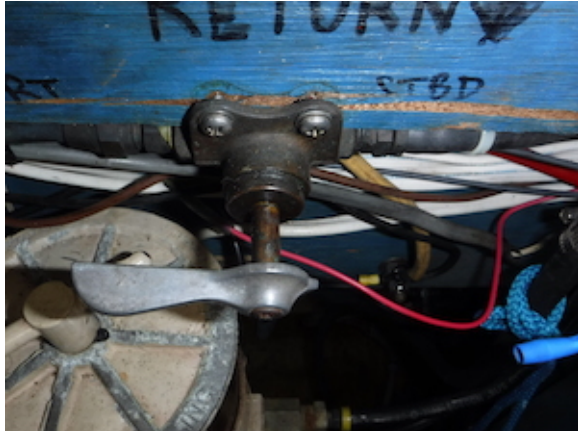
The fuel hoses are in good condition and are USCG rated A1 and A2. One fuel valve is leaking. The electric fuel pump is not operational.

B.12, B.13 (see findings and recommendations)

B.11 The fuel tanks are corroded.	Closely monitor or replace the fuel tanks.
B.12 One fuel valve is leaking.	Replace the leaking fuel valve.
B.13 The electric fuel pump is not operational.	Make the fuel pump operational.
B.14 The fuel separator was full of water.	Service the fuel separator and filter. Inspect the fuel system to determine the cause of water in the fuel system.
B.15 The mizzen mast step appears undersized to support the mizzen mast.	Monitor the mast step for cracks or warping, or provide additional support to the step.
B.16 There is some corrosion at the chain plates.	Clan and monitor the chain plates for corrosion.
B.17 There are loose wires in the lazarett.	Secure all wires every 18" and provide strain relief.
B.18 There are no covers on the battery terminals.	Install covers on the battery terminals.
B.19 There are wires and cables in the center of the aft cabin.	Protect the wires in the aft cabin with a ridged pole.

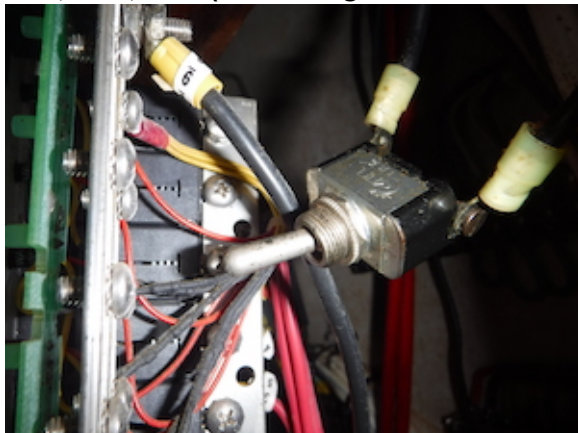
The main panel is located in the salon and is operational and properly labeled. The anchor light switch is broken. There is a loose metal switch behind the electrical panel. The electrical panel is not secure.

B.21, B.22, B.23 (see findings and recommendations)

B.20 There is one loose battery terminal.	Tighten the nuts on the battery terminals.
B.21 The anchor light switch is broken.	Replace the broken switch.

B.22 There is a loose metal switch behind the electrical panel.	Secure the loose switch behind the panel.
B.23 The electrical panel is not secure.	Secure the main panel.
B.24 The engine alternator does not appear operational.	Prove operational or repair as necessary.
B.25 The aft head did not pump water.	Prove operational or repair as necessary.
B.26 There are no vented loops in the water supply hoses to the heads.	Install vented loops to the hoses to the heads or keep the valves closed when not in use.
B.27 There is a notable holding tank odor.	Monitor the holding system for leaks.
B.28 There is some fluid at the steering ram.	Monitor or repair the steering ram.
B.29 Several seacocks are stuck open, some with corrosion, some with evidence of leaks.	Exercise, repair, or replace the seacocks.
B.30 The bilge pump is not secure.	Secure the bilge pump.
B.31 The bilge pump float switch is not operational.	Repair or replace the bilge pump float switch.
