So Cal Surveys, LLC

Survey Report

Formosa 51

Eagle

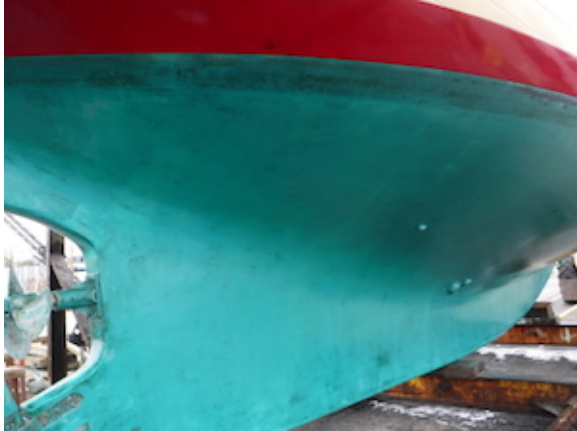
The hull is constructed of fiber-reinforced plastic with an internal ballasted keel. The gelcoat above the waterline is in good condition. The interior of the hull is in good condition where accessible. The paint below the water line is in fair condition. Percussion soundings to the hull found no damage or delamination. No blisters or cracks were sighted.

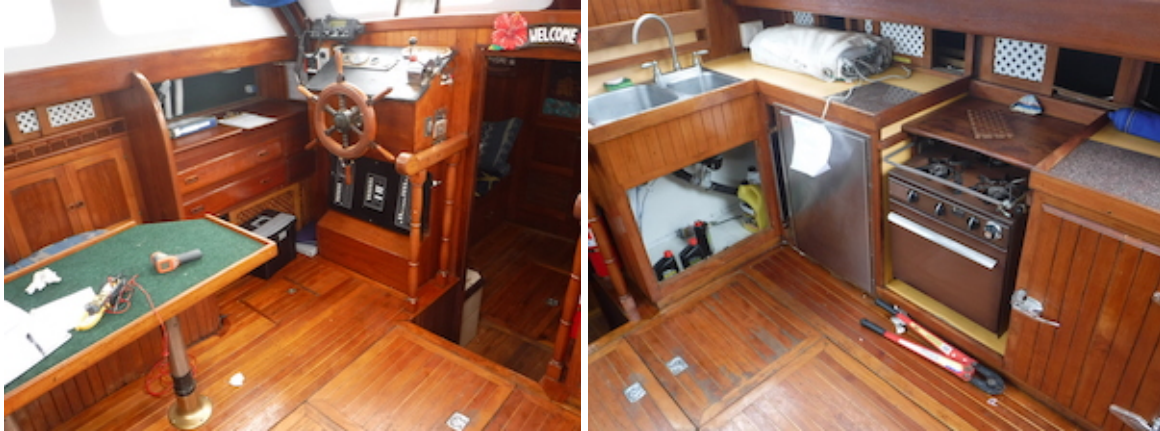
The galley is in fair condition. The engine-driven refrigerator appears operational. The stainless-steel sink and countertops are in good condition. The propane stove appears operational and in fair condition. The propane tank is stored in the dedicated propane locker.
